# POTASSIUM CORROSION TEST LOOP DEVELOPMENT

Quarterly Progress Report No.10 For Quarter Ending January 15, 1966

prepared for NATIONAL AERONAUTICS AND SPACE ADMINISTRATION Contract NAS 3-2547

SPACE POWER AND PROPULSION SECTION
MISSILE AND SPACE DIVISION
GENERAL ELECTRIC
CINCINNATI, OHIO 45215

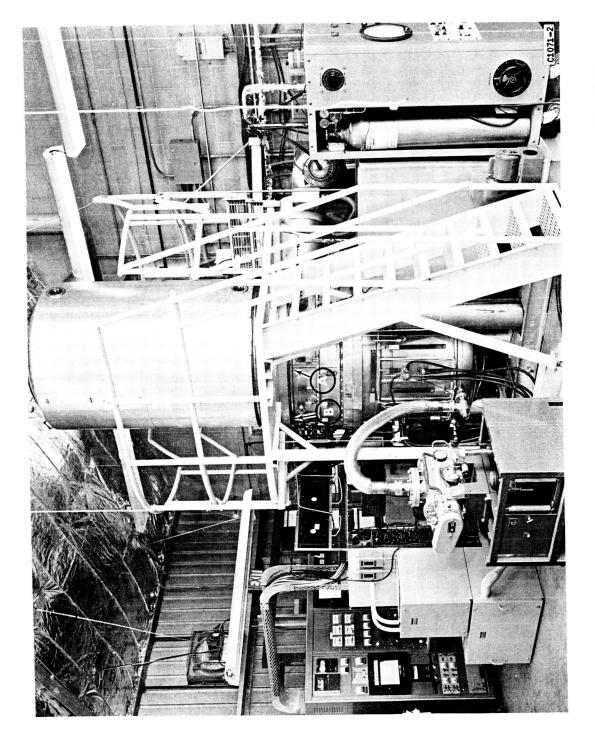
Prototype Corrosion Loop Test Chamber and Associated Equipment. Water Channel in Which Stress-Corrosion Cracking Occurred is Indicated by Arrows. (C65080602) Arrows. Figure 2.

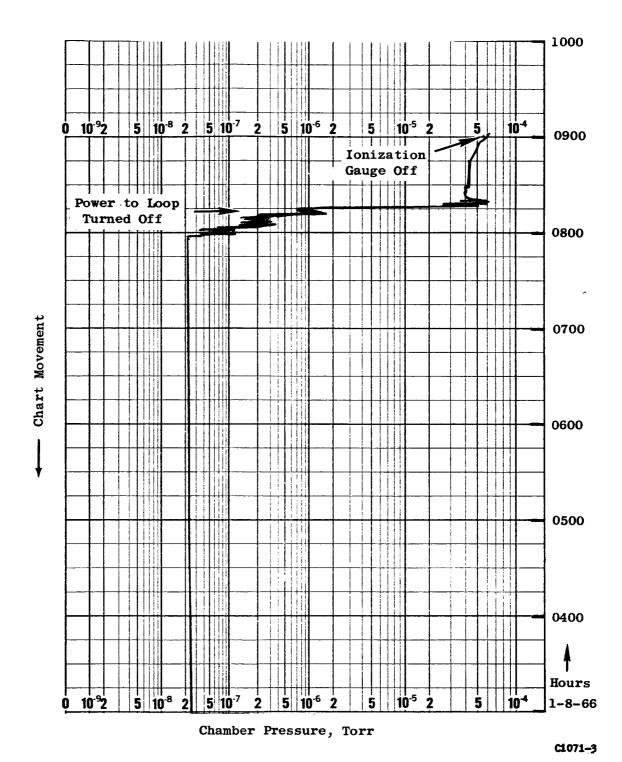
Pressure Rise. At approximately 0800 on January 8, 1966, the test was shutdown after 3,809 hours of continuous operation because of a pressure rise in
  the vacuum chamber. As shown in Figure 3, the pressure rose rapidly from the
  normal level of  $2.1 \times 10^{-8}$  torr to approximately  $1 \times 10^{-6}$  torr in 17 minutes.

Since the pressure trace gave no indication of being an argon instability, as
  first suspected, the test engineer gave instructions to shutdown the test.

Figure 3. Prototype Loop Vacuum Chamber Pressure During Period When the Test was Shutdown Because of a Water-to-Vacuum Leak in the Top Cooling Channel of the Spool Piece.

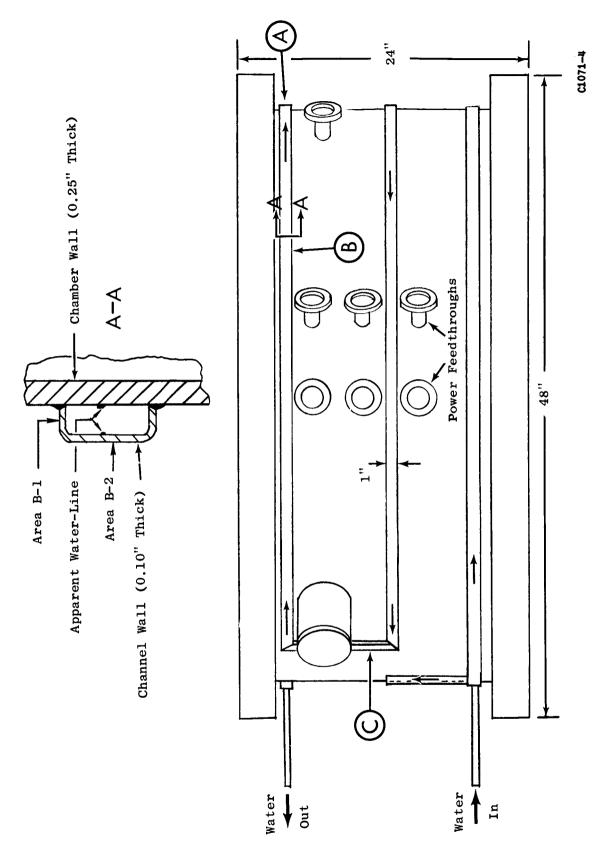
3. Description of Spool Piece, Examinations and Evaluation of the Cooling Channel Failure. A sketch of the spool piece is shown in Figure 4. The water channels on this component and the direction of the water flow are indicated. A cross section of a typical channel is also illustrated. During the leak checking operations it became apparent that a large water-to-vacuum leak was present in a region where the top cooling channel of the spool crossed a vertical weld in the chamber wall. The channel in this region was cut away as shown in Figure 5 and an attempt was made to repair a visible crack in the chamber wall by welding. This only resulted in the opening up of a multitude

Spool Section of Vacuum Chamber Showing Locations, A, B, and C, Where Portions of the Cooling Channel Were Removed. Gross Section of Top Channel Shows Location of Metallographic Samples, B-1 and B-2, and Location of the Water-Line Deposits. Figure 4.

Hardness surveys were conducted on the metallographic specimens taken from the cracked region, B-1 in Figure 4, and the uncracked region, B-2, in Figure 4. The average of ten hardness impressions in the cracked region yielded a DPH\* value of 172. The average hardness value obtained in the uncracked specimen was DPH-151. These hardness values may be compared with handbook (7) values for Type 304 SS which indicated the following hardnesses in the various conditions: annealed-DPH-125, 10% cold work-DPH-160, and 20% cold work-DPH-205. This comparison suggests that both the upper portion (B-1) and the vertical portion (B-2) of the channel had the equivalent of approximately 10% cold work, which would be sufficient to contribute to stress-corrosion cracking if the other conditions, such as chloride and dissolved oxygen in the water, were also present. Although there was metallographic evidence of cold work in the structure of the channel in the bends (DPH-200), the structure of the specimens in the flat regions of the channel (DPH-151-172) showed little evidence of cold work (see Figures 9 and 10).

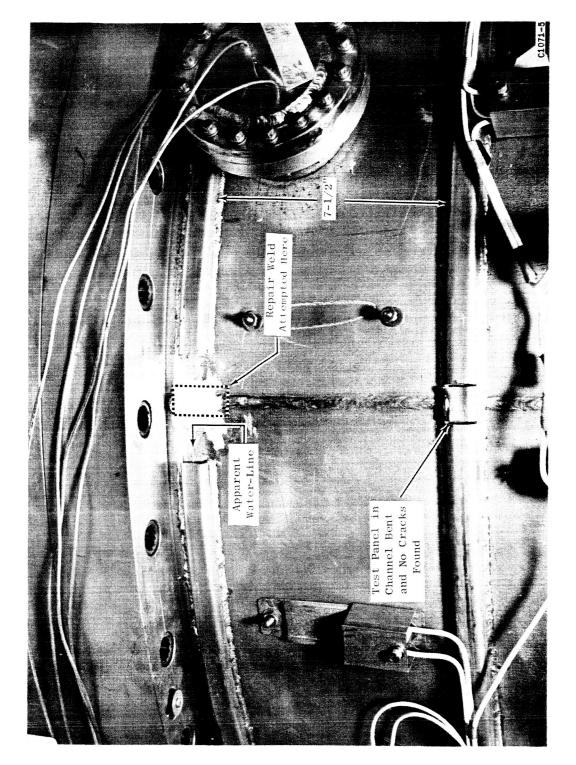
Figure 5. Upper Portion of the Spool Piece of the Chamber Corresponding to Area (A) in Figure 2 Showing Where First Section of Cracked Water Channel was Removed. Lower Channel was Found to be Ductile and Free of Cracks. (C66011401)

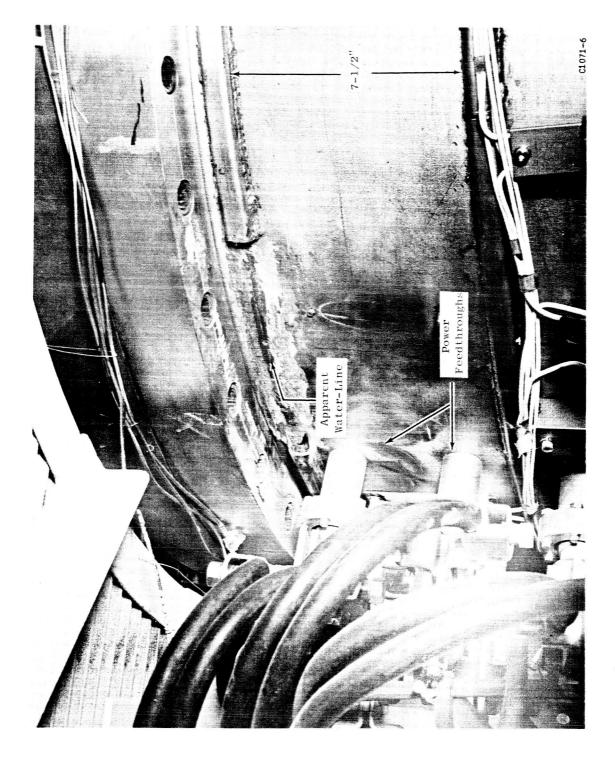
of cracks in adjacent portions of the chamber wall. At this point corrosion of some type was suspected and another section of top channel approximately 10 inches long was removed for additional inspection. This area is shown in Figure 6. Examination of the section of removed channel indicated gross cracking of the 0.1-inch thick channel as shown in Figure 7. Figure 7(a) shows the inside surface of the top portion of the channel. Numerous marks made by the grinder used to remove the channel are evident. The complete destruction of the channel wall is apparent in Figure 7(b) which is an enlarged view of a segment of the channel following slight bending. Visual inspection of the chamber wall proper also indicated a multitude of cracks in the upper portion of the channel. Close examination of the cutaway regions of the chamber wall shown in Figure: 5 and 6 revealed a thin line of white deposit near the mid-height of the channel. A corresponding line was found on the segment of channel which had been removed. A portion of this channel was bent so that equal amounts of deformation were given to regions above and below the deposit line. This specimen is shown in Figure 8. The line of white deposits and cracking observed in the region above this line are shown in this photograph. No cracks were detected in the deformed segment of channel located below the deposit line.

Figure 6. Upper Portion of the Spool Piece of the Chamber Corresponding to Area (B) in Figure 2 Showing Where Section of Cracked Water Channel was Removed. (C66011403)

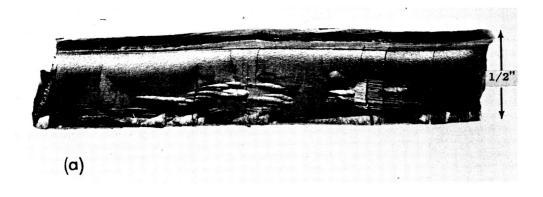
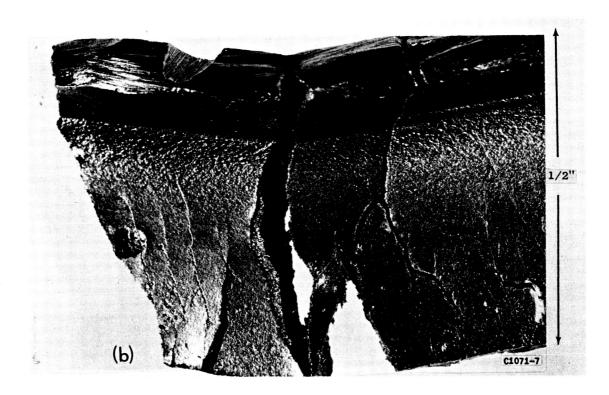
a) C66012125; b) C66011802

Figure 7. Water Side of the Top Portion of the Upper Cooling Channel of the Chamber Spool Piece. Section Shown was Taken from Area B-1 Indicated in Figure 4. Sample Shown in (b) is Typical of the Region Shown in (a) After Slight Bending. Grinding Marks on the Surface Shown in (a) Occurred During Removal of the Channel.

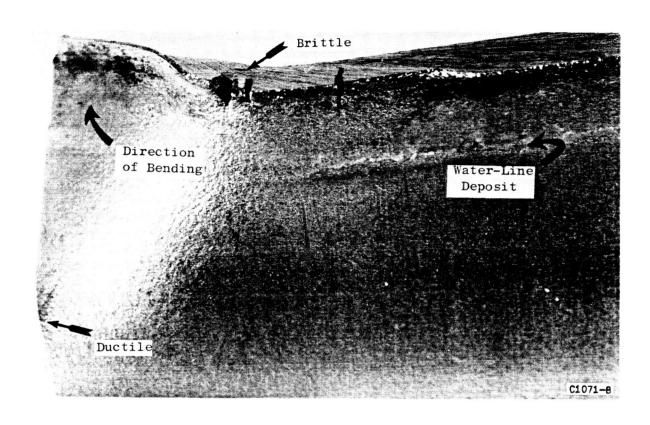
Figure 8. Appearance of Water Side of a Specimen Cut From the Region of the Top Cooling Channel Nea: the Water-Line Deposit. Corner of the Specimen was Bent to Illustrate Brittleness of the 0.10-Inch Thick Channel Above the Deposit Line. (C66011803)

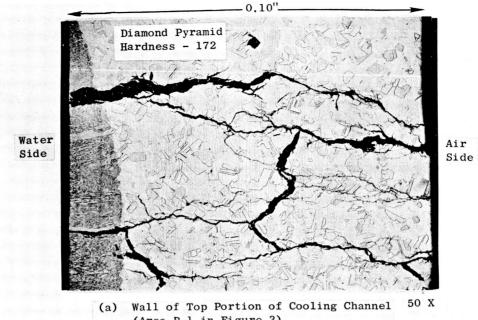
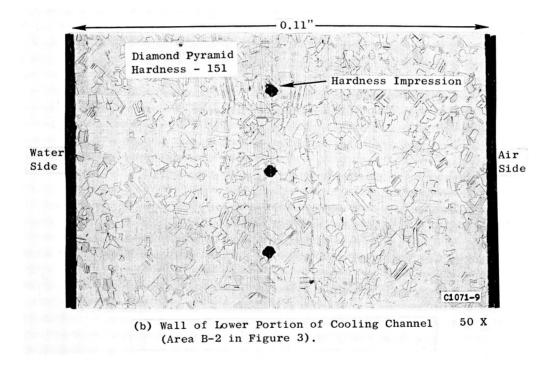
Metallographic examination of cross sections of the channel from the lower, uncracked region and the upper, cracked region are shown in Figure 9. (The hardness impressions shown are discussed later in this report.) Additional photomicrographs of the cracked regions are shown in Figure 10 at higher magnifications. The transgranular nature of the cracks are typical of stress-corrosion cracking in austenitic stainless steels (3).

Metallographic Sections of the Top Portion (a) and Lower Portion (b) of the Figure 9. Upper Water Cooling Channel of the Chamber Spool Piece.

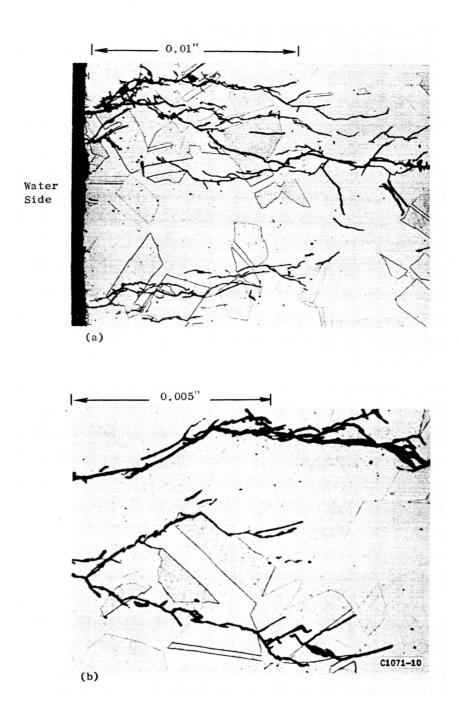
Figure 10. Photomicrographs of the Water Cooling Channel Wall at Two Magnifications. Note the Transgranular Nature of the Cracks Typical of Stress-Corrosion Cracking.

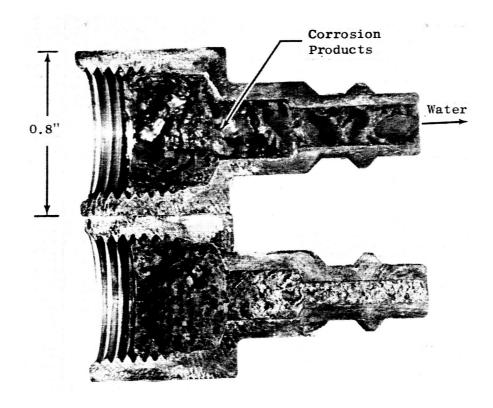
C1071-11

The critical factors associated with most of the stress-corrosion failures discussed in the ASTM report (4), i.e., fabrication and welding stresses, chlorides, and dissolved oxygen, were present in the chamber cooling channels. It seems most probable that the localized nature of the failure in the top half of the upper channel of the spool piece was caused by concentration of chlorides on the walls in this region. The water-line deposit shown in Figures 5, 6, and 8 indicates that this channel was only partially filled by the cooling water. The partially filled condition in this channel is attributed to: a) extensive blockage of the inlet and outlet water flow in the spool piece by the accumulation of corrosion products in the water-line fittings as illustrated in Figure 11, and b) the location of the water outlet fitting at the mid-point of the top channel. The location of the fitting at this point permitted the channel to drain to the approximate location of the water-line deposit with the low flow condition which resulted from the partial blockage of the restrictions in the inlet and outlet fittings.

Figure 11. Cadmium-Plated Steel Fitting Used to Connect Water Inlet and Outlet Lines to Spool Piece Cooling Channel. Both Inlet and Outlet Fittings Partially Plugged with Corrosion Products. (C66012124)

- c. Valves will be placed on the outlet side of each of the water cooling circuits.
- d. Stainless steel fittings will be used to replace the cadmium plated steel quick disconnect fittings in the water cooling circuits.

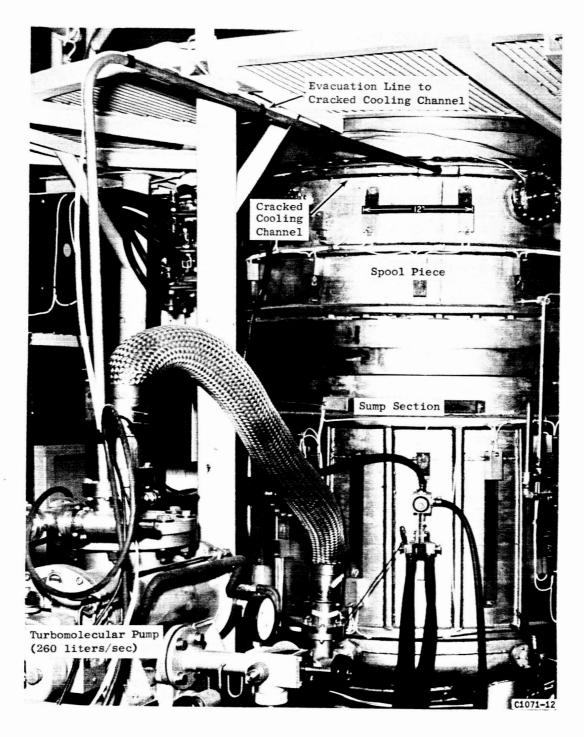
(C66031015)

Figure 12. Spool Piece and Sump Section of the Prototype Corrosion Loop Test Chamber Showing the Evacuation Line and the Turbomolecular Pumping System Used to Pump Cracked Cooling Channel to a Pressure of  $10^{-8}$  Torr.

The phenomena responsible for the failure seems to be quite obvious at this time. The cracked channel has been isolated from the other channels and will be pumped by a vacuum system independent of the main chamber pumping system. The repaired channel and the turbomolecular pumping system which will be used to maintain the pressure in the "cracked" channel in the  $10^{-7}$  -  $10^{-8}$  torr range is shown in Figure 12.

<sup>\*</sup> The removed segments of the channel were replaced with new stainless sheet and the remaining cracks were sealed with epoxy resin recommended for vacuum applications,
